Technical Service Bulletin

COMPLIANCE: ADVISORY
SUBJECT: LOWER IONIZATION DUE TO COILED HIGH VOLTAGE CABLES
AFFECTED UNITS: ALL GPS-IMOD™ UNITS
DESCRIPTION:

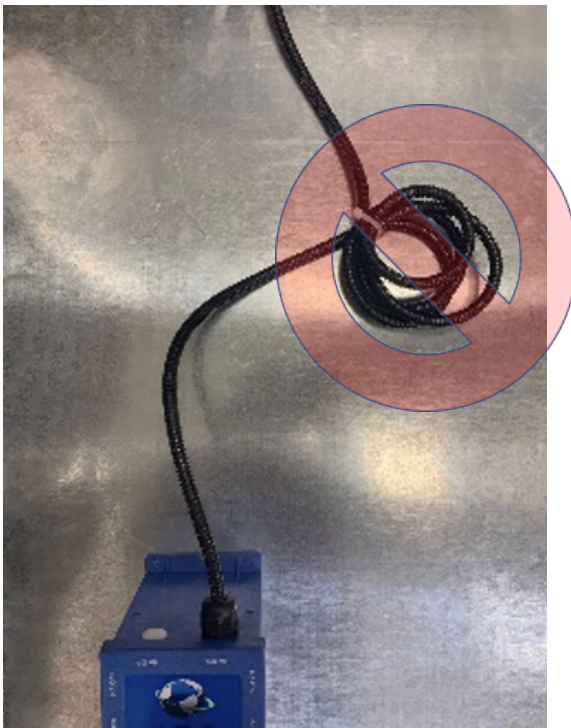
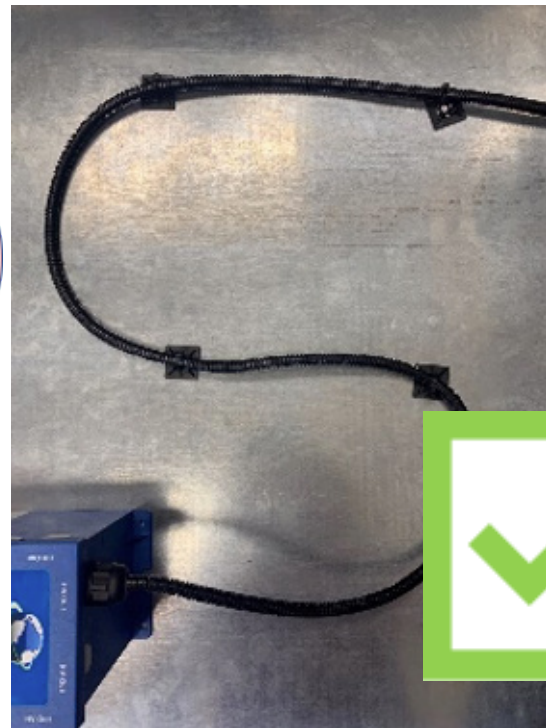
The coiling or bundling of high voltage (HV) cables can cause arcing and decreased ion output from the iMod. Installations where the cable(s) are touching in multiple locations will experience reduced output and lifespan. If the HV cable(s) is similar to the below picture, action is strongly recommended.

Do not cut or alter high voltage cables. Cables 15ft long can be ordered if additional length is required. Do NOT coil, bunch, or loop the cable up so that it comes in contact with itself. To reduce slack in the cable, create long sweeping "S" shapes, like switchbacks in a road. High voltage cable should be routed with soft bends only such as creating long sweeping "S" shapes. Minimum bend radius is 3". Maximum bend angle is 70 degrees. Secure the cable(s) so they will not interfere with or be damaged by equipment or personnel.

The proper routing of cabling is shown above.
